PORT CHILKOOT DOCK CONDITION ASSESSMENT (PRE 1994 FACILITY)

PORT CHILKOOT DOCK CONDITION ASSESSMENT

Re: Port Chilkoot Dock Condition Assessment

Pre-1994 Facility

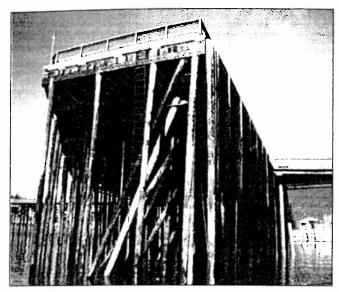
South end of dock, looking north.

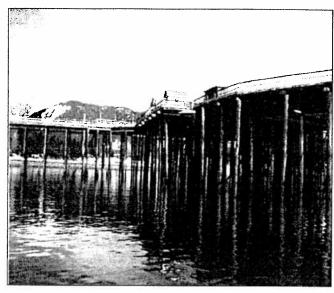
Back side of dock and trestle intersection, looking north.

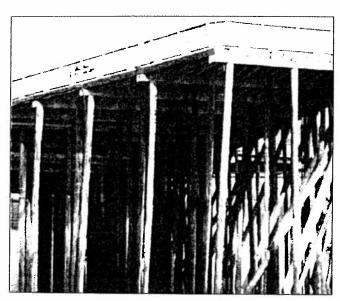
South west (angled) side of dock, looking north.

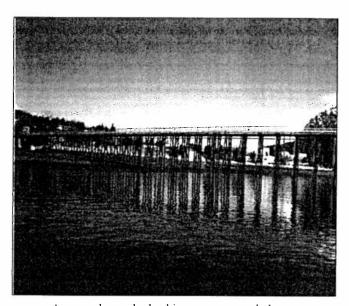
Approach trestle, looking west toward shore.

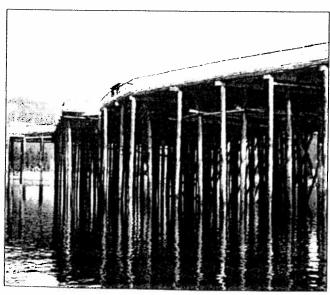
Backside of dock, looking north.

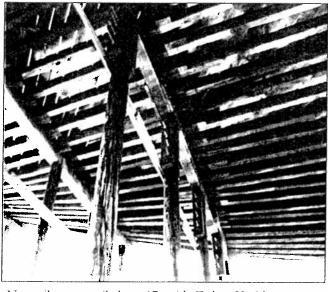
New pile cap at pile bent 17, grids E thru K. New stringers and decking for repair of 2006 forklift damage.

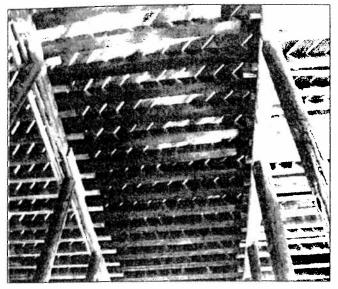
New 10 x 12 stringers installed between bents 16 and 17 and grids A thru E.

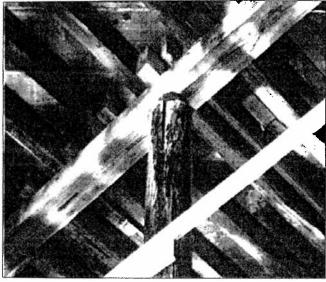
- The tops of piles 4I, 5K, 8K, 9K, 11E, 15D, and 16F are split.
- The tops of piles 5K and 16F have been displaced but are still under the pile cap.
- The drift pin atop pile 5K has been torn out as a result of the displacement of this pile.

Pile 16-F split at top and displaced from centerline of cap.

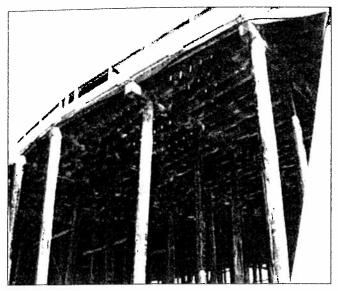
Pile caps, stringers at back side of dock.

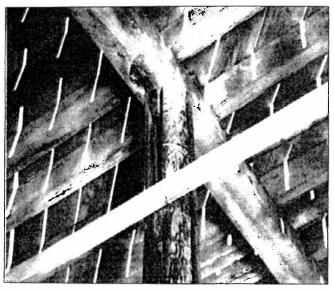
Pile 5-K drift pin torn out of pile. Pile displaced approximately 12 inches parallel to cap.

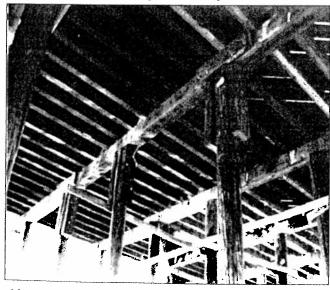
New pile cap at bent 7, grids I, J and K, with new splice plates and bearing plates.

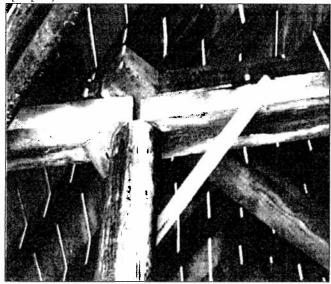
Pile 5-C cap butt splice with no splice plates and minimal bearing.

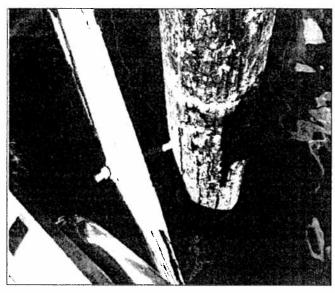
- The cross bracing at pile bent 20 is missing the mid-point blocking. Due to the length of the cross bracing, this blocking is necessary at the brace mid-point to prevent excessive deflection of the bracing. While the cross bracing at this location still offers some lateral capacity, the capacity is significantly reduced as a result of the missing blocking.

Missing cross brace blocking at trestle bent 20, grid C.

- Cross bracing is structurally critical for the approach trestle. It is recommended that the cross bracing identified above, and all related connection hardware, be replaced with new.

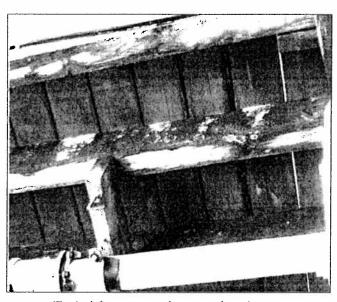
- The pile caps ends at bents 25, 26, 28, and 29 are split and deterioration of the wood has begun.
- Virtually all stringers and many pile caps have a moderate amount of fungal growth on them
 indicating that the original creosote treatment is no longer doing an adequate job of protecting the
 wood.

Typical fungus growth on trestle stringers.

- Framing (i.e. stringers and pile caps) for the approach trestle is no longer being adequately protected by the creosote timber treatment. Consequently, deterioration of these timbers has already begun. It is recommended that a 5-year replacement plan be implemented for the approach trestle. Each year, a portion of the pile caps, stringers and decking should be replaced with new. All trestle pile caps, stringers and decking should be replaced with new, within 5 years.

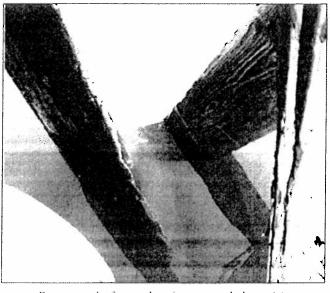
- The cross bracing at pile bents 3, 4, 5, 6, 13 and 14 have rotten and/or broken ends. Consequently, these cross braces no longer have an adequate structural connection to the piles, and thus do not provide the necessary lateral support for the trestle structure at these locations.

Rotten end of cross bracing at trestle bent 14.

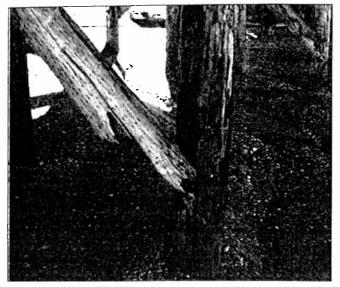
Rotten/broken cross bracing at trestle bent 4.

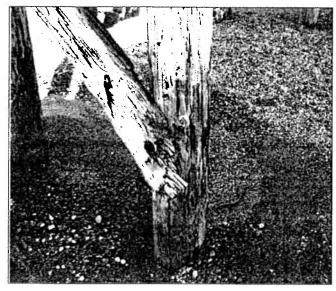
Rotten/broken cross bracing at trestle bent 3.

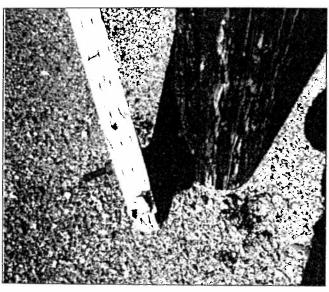
Rotten/broken cross bracing at trestle bent 5.

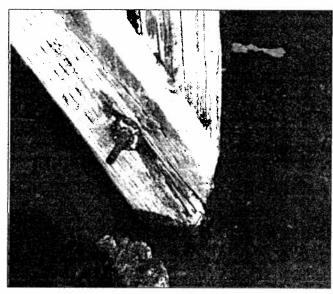
Rotten/broken cross bracing at trestle bent 6.

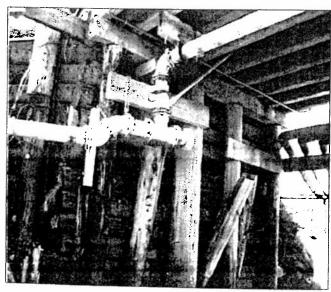
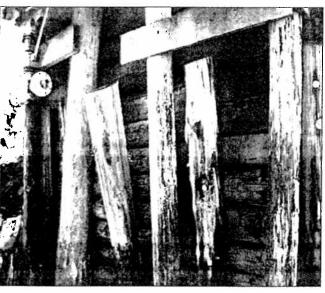
Piles and pile cap at trestle abutment.
